APM STATIONS CONDITION ASSESSMENT

Project Number: 83498

June 2015

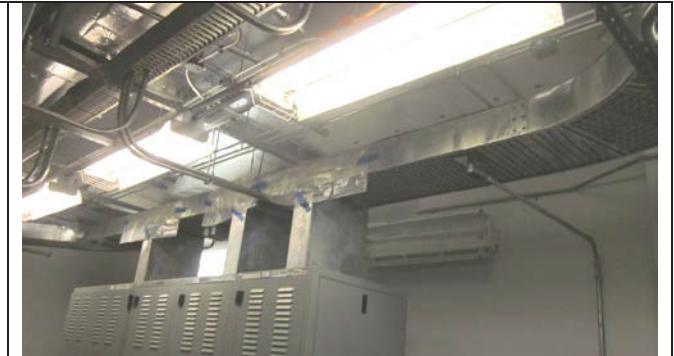
General view of APM Equipment Room (A407). Note poly over the cable trays

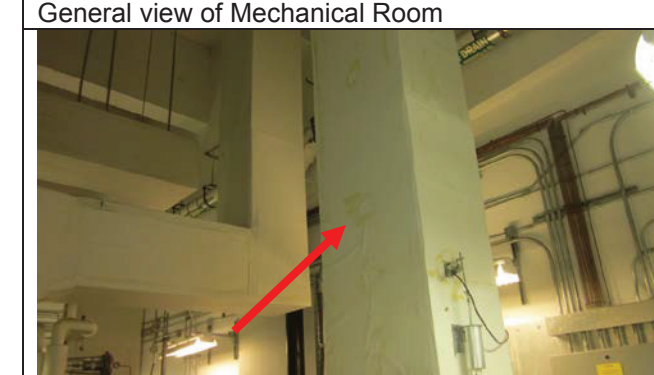
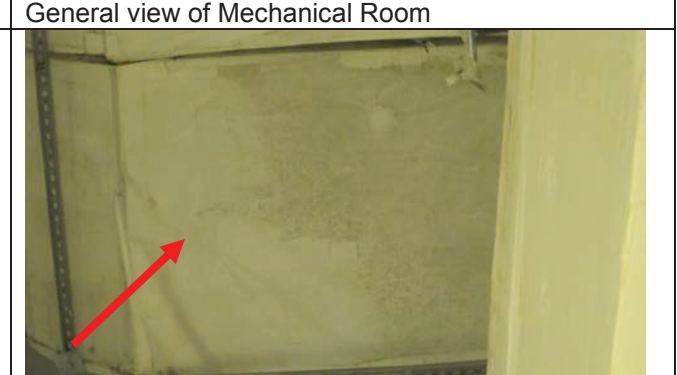
Mechanical Room water staining on duct system	Mechanical Room water staining on duct system

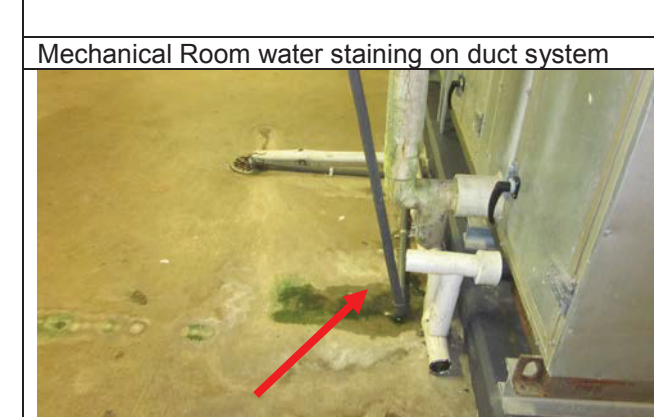
Mechanical Room water staining/algae growth on concrete floor at drain	Mechanical Room water staining/algae growth on pipe insulation

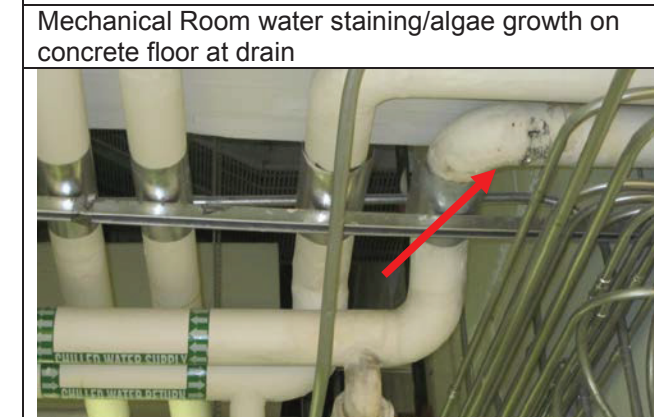
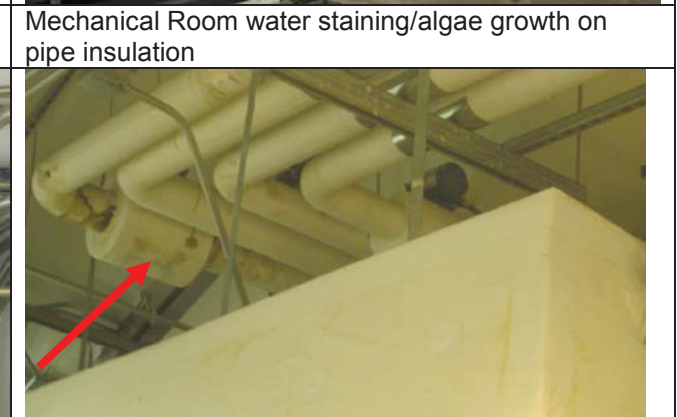
Mechanical Room visible mold growth on pipe insulation	Mechanical Room visible mold growth on pipe insulation

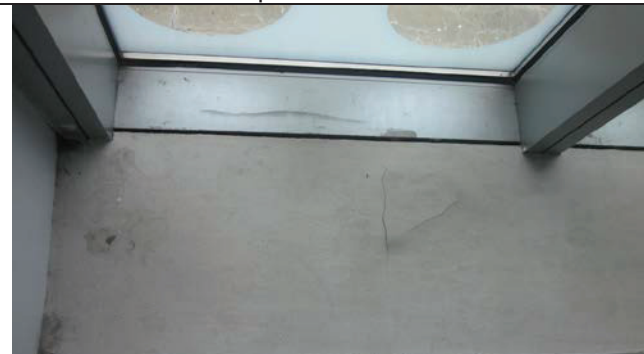
Example of observed water staining on window sill on the APM Level
