IAH APM CONDITION ASSESSMENT

**BUSH INTERCONTINENTAL AIRPORT HOUSTON (IAH)
HOUSTON, HARRIS COUNTY, TEXAS**

October 2021

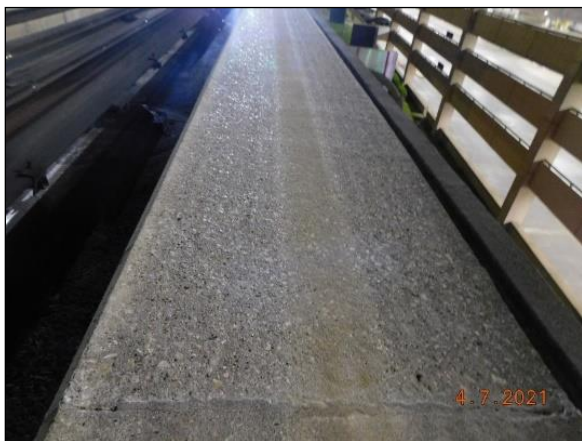
Figure 3.1

In general, the running beams were found in good condition, but evidence of distress was observed. For instance, the top surface of the running beams was generally slightly abraded due to wearing caused by the APM wheels (see **Figure 3.1**). The abrasion was considered minor as very few small spalls or pop-outs in wheel path were observed (see **Figure 3.2**). Abrasion damage was slightly more pronounced near the terminals where APM braking forces wear the concrete surface more quickly.

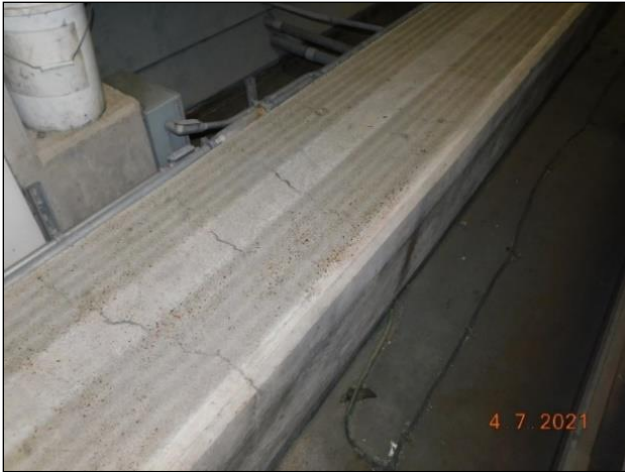
Figure 3.3

Another very common type of damage observed in the running beams was transverse cracking. Cracks were observed along the running beams in every span with spacings varying between 2 and 6 feet. Crack width generally varied between 0.01 inch and 0.05 inch (see **Figure 3.3** and **Figure 3.4**). The pattern and spacing of cracking is consistent with restrained volumetric changes in the concrete beam.

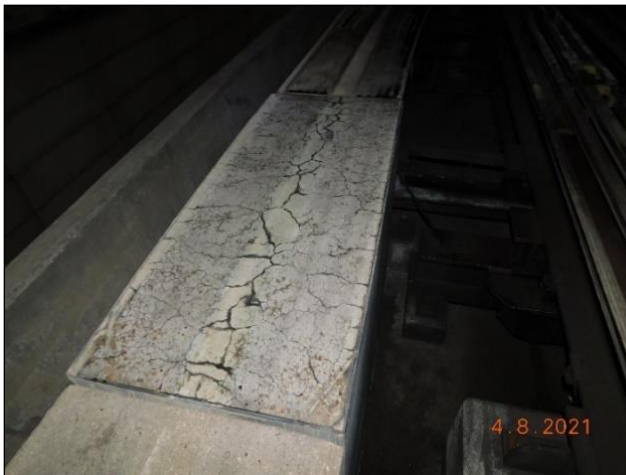
Figure 3.5

Additionally, map cracking on top of running beams (**Figure 3.5**) and cracking under the running beams (**Figure 3.6**) was observed. The map cracking ranged from minor to moderate to severe. Cracking under the running beams were found at switches near the MSF facility, and cracks were about 0.01 inches in width and between 4 inches long up to the full height of beam.

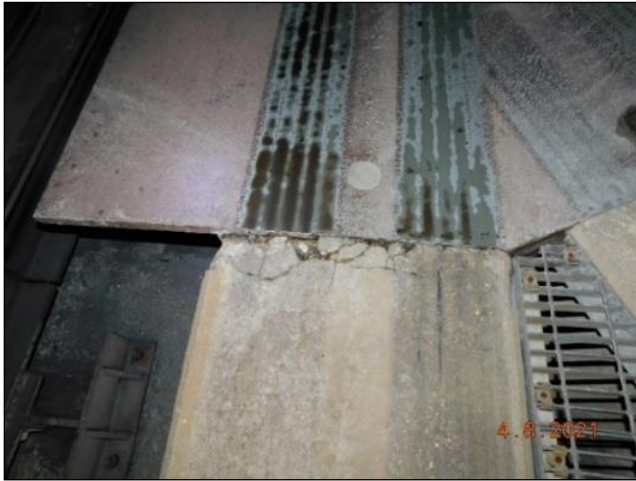
Figure 3.7

Spalling of the running beams and loose concrete were observed at switches in transitions between running beam and metal switch plate (**Figure 3.7** and **Figure 3.8**). Spalls and cracking were also very common at relief joints (**Figure 3.9**) likely from a punctured APM wheel. The depth of spalling varied between 1 and 5 inches, and in one instance the reinforcing steel was exposed. At these locations reinforcement cover is significantly reduced which is an important durability issue.

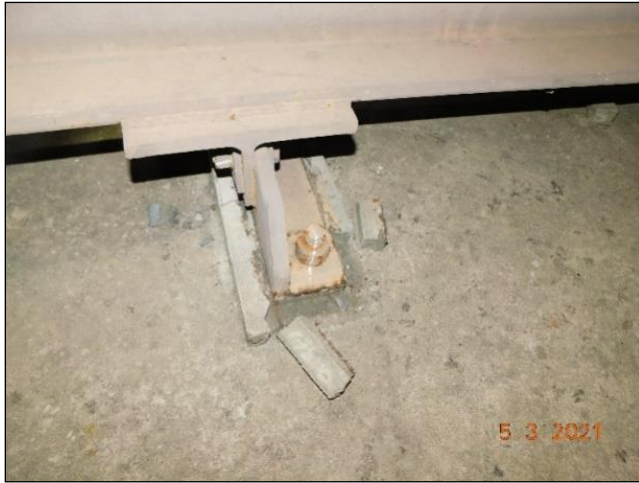
Figure 3.10

As discussed in **Section 2.1**, the steel guide beams are anchored to the deck slab using anchor rods embedded in the concrete. In most cases, grout pads were placed in the gap between the connection steel angle and the deck slab to provide a uniform bearing surface. These connections were not a focus of the inspection. However, major issues were noted including a spalled grout pad (**Figure 3.10**) and missing bolts (**Figure 3.11**). These damaged grout pads should be retrofitted to avoid further damage and eventual effects on the steel beams.

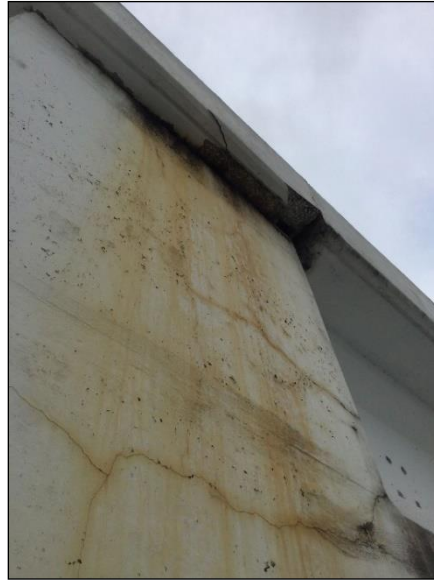
Figure 3.17

The deck curb over the bents 43, 44, and 45 is severely delaminated. As time passes the delaminated concrete may spall off completely and pose a danger to the traffic below. It is recommended that APM authorities remove the delaminated concrete in a controlled manner as soon as possible. See **Figures 3.16-3.17** for delaminated sections.

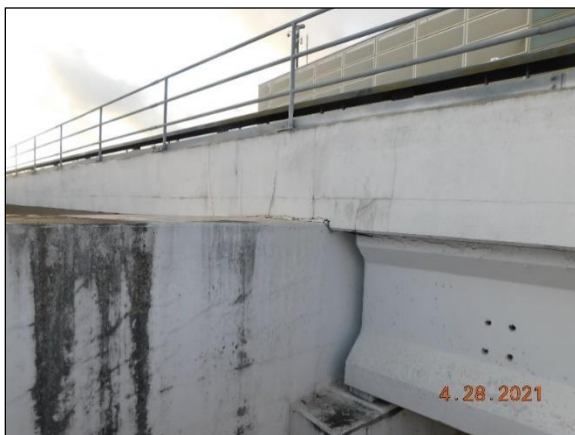
Figure 3.18

Vertical cracking was observed in the parapet walls at the edges of the slab along the entire length of the slab, likely due to the restrained concrete shrinkage. Cracks measured widths between 0.01 and 0.02 inches and occurred every 2 to 3 feet (**Figure 3.18**). Over the bent locations, these cracks are more pronounced and extend underneath the deck. Cracks have widths up to 0.04 inches and are closely spaced, between 12 and 18 inches (**Figure 3.19**). These cracks may be caused by negative moment tension stresses.

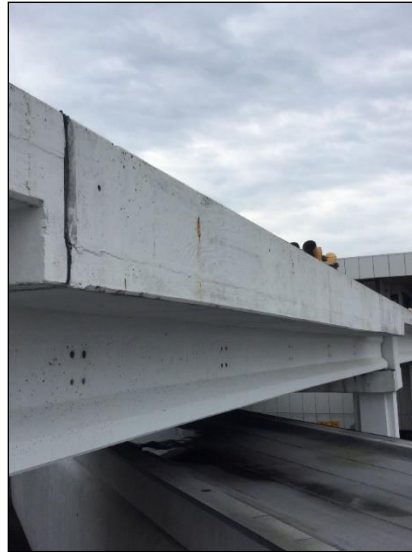
Figure 3.20

Horizontal (longitudinal) cracking was observed on the parapet walls at the edges of slabs throughout the inspection (**Figure 3.20**). Cracks have widths of approximately 0.01 inches. Cracking may be caused by the

casting operation of the exterior curb portion of the slab. Horizontal cracking is also more prominent over the bent caps.

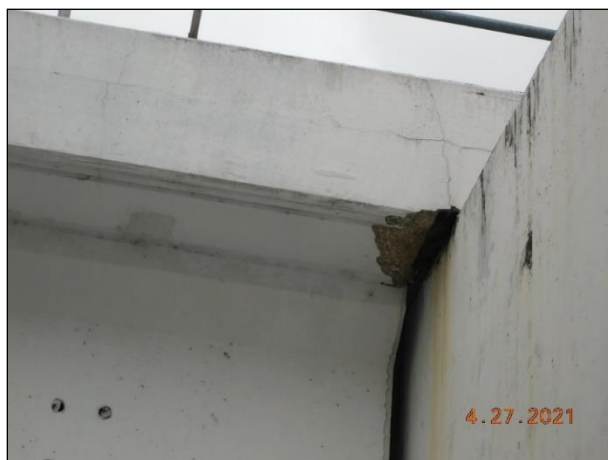
Figure 3.21

Spalls and concrete delamination were observed on deck edges all along the APM guideway. These spalls are likely due to stress concentrations and were more common at deck overhang interfaces with other bridge components such as the bent (see **Figures 3.21, 3.22, and 3.23**). Generally, the spalls do not show any evidence of active corrosion.

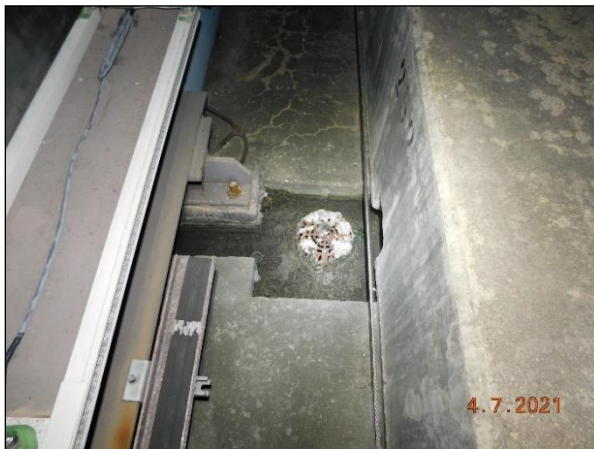
Figure 3.24

At a few of the bent locations, the deck drains were clogged, and the drainage troughs were filled with debris. **Figure 3.24** and **Figure 3.25** show two of the clogged deck drains. Clogging may be due to a combination of lack of grates protecting the drains and lack of maintenance. The observed clogging may be indicative of other drainage issues inside the cap or column. However, this was not inspected as part of the investigation for this report.

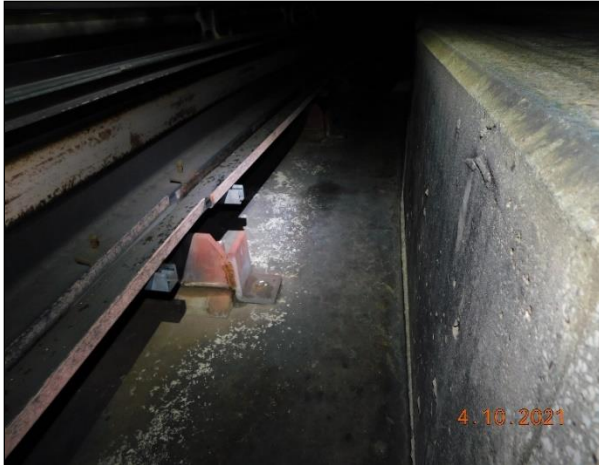
Figure 3.26 shows evidence of standing water (ponding) and **Figure 3.27** shows evidence of algae growth on the deck. It is believed that deck ponding was caused by uneven finishing of the slab top surface. While water alone would not cause damage to the slab, it may eventually lead to reinforcement corrosion.

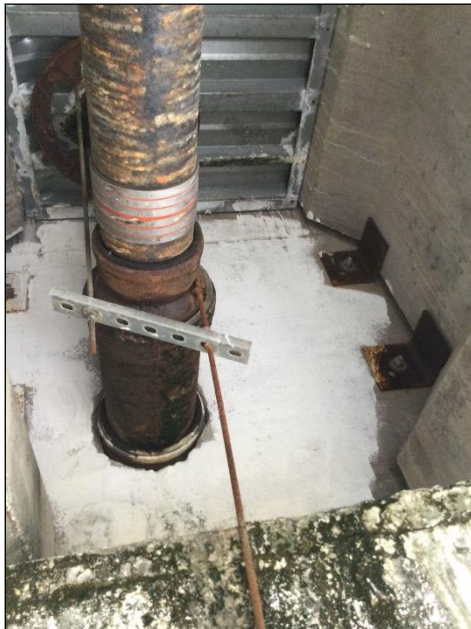
Figure 3.28 shows a loose drainage pipe support on the East face of Bent 49 between beams 1 and 2. On the west face in the same location of the same bent, **Figure 3.29** shows a deck drainage pipe. The entire deck drainage pipe saddle support is detached.

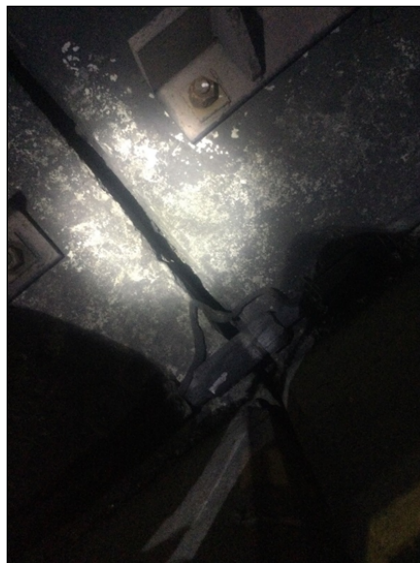
Figure 3.30

Deck expansion joints were typically observed to be in poor condition. Seals and compressible particle boards were generally loose, deteriorating or missing (see **Figure 3.30** and **Figure 3.31**). As a result, it is very common to have water leaking through the expansion joints and subsequent staining of the structure below. These stains are not only unsightly, but leakage can reduce the long term durability of the concrete elements exposed to the wetting and drying cycles. This will eventually trigger deleterious reactions in the concrete or corrosion of reinforcing steel.

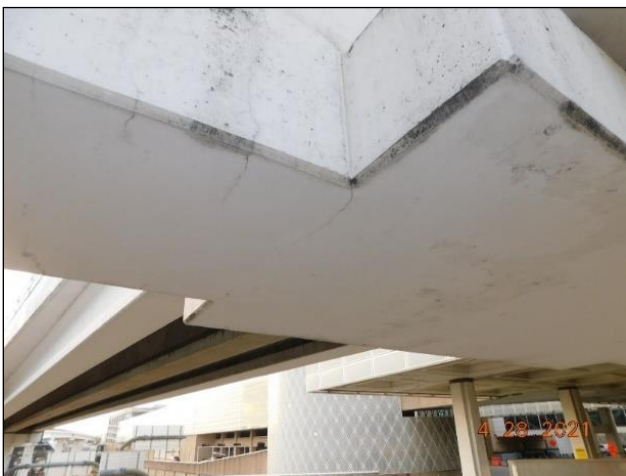
Figure 3.34

Vertical cracking is common on the side faces of the bent cap stem on both the hammerhead and straddle bents. Most of the cracks are located at the bottom of the stem section spaced every foot and can extend to the underside of the cap (**Figure 3.34** and **Figure 3.35**). Some of the vertical cracks also extend through the entire height of the section. Crack widths measured from 0.01 inches to 0.02 inches.

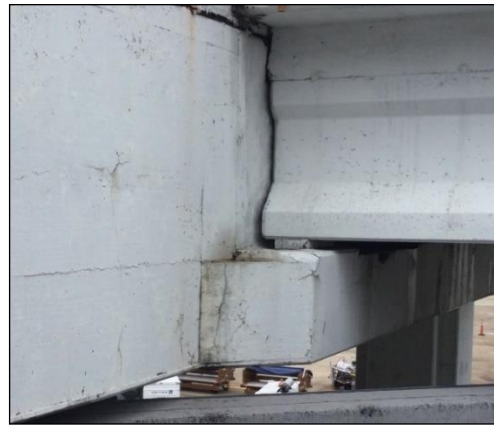
Figure 3.37 shows the typical cracking at the interface between the ledge and the stem. These cracks correspond to a classic shear-friction limit state for the ledge. The width of these cracks varied from 0.01 inches to 0.02 inches.

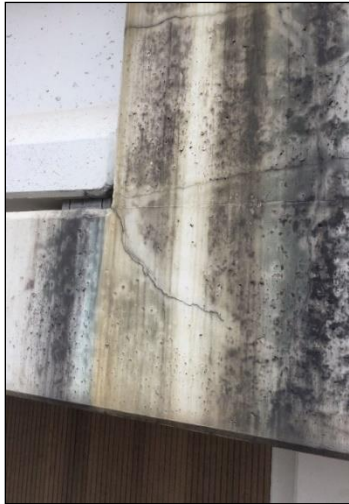
Figure 3.38

Widespread and significant cracking was observed at the end face of the caps of the inverted-T section. Typical cracking observed was diagonal cracking that originated from the corner ledges. **Figure 3.38** shows this typical cracking. **Figure 3.39** shows the diagonal ledge cracking that progressed from both corners of the inverted-T ledge and morphed into one horizontal crack and then wrapped around the face of the stem. Crack widths varied from 0.01 inches to 0.02 inches.

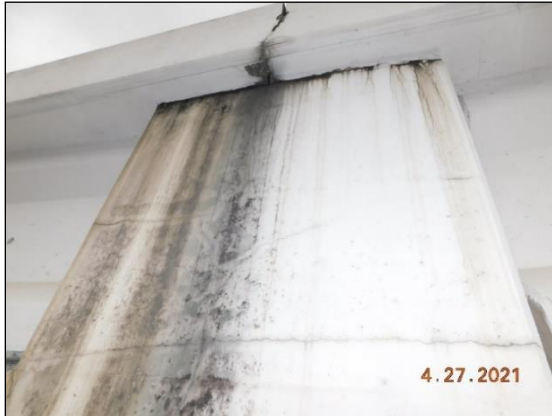
Figure 3.40

Another type of crack that was observed on the inverted-T section is shown in **Figure 3.40** and **Figure 3.41**. These large horizontal cracks were located at mid-height of the stem. The cracks extended the full width of the stem and into the length of the cap. The crack widths were measured to be between 0.01 inches and 0.03 inches.

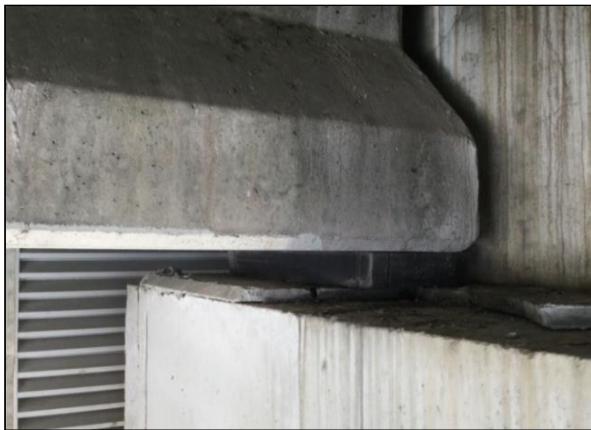
Figure 3.44

Some grout pads were spalled with loose concrete. In severe cases, the spalls would leave the bearing pad unsupported in sections (see **Figure 3.44** and **Figure 3.45**). **Figure 3.46** shows a grout pad at bent 47 that contains loose concrete and is in danger of falling.

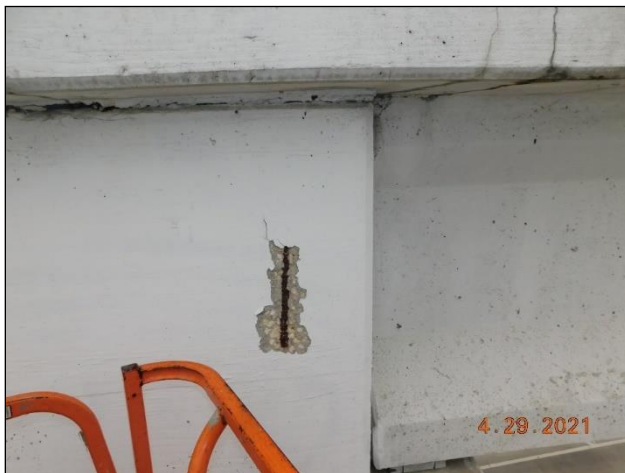
Figure 3.47 shows an instance of exposed rebar. **Figure 3.48** shows delaminated concrete that is close to spalling off. **Figure 3.49** and **Figure 3.50** show two 2.5 foot spalls at the top of the stem.

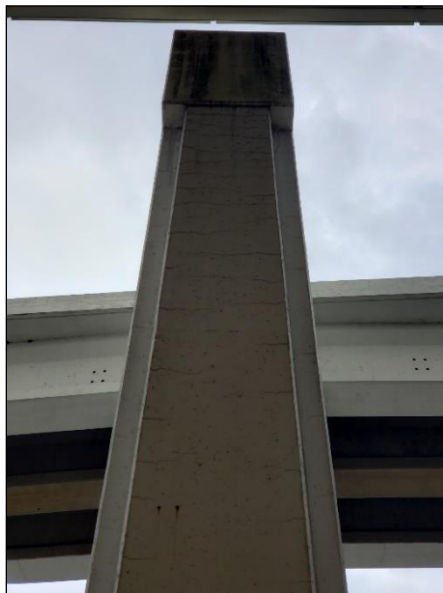
Figure 3.51

In general, the columns were in relatively good condition although deficiencies were recorded in most columns. Widespread horizontal cracking was observed in most columns as shown in **Figure 3.51** and **Figure 3.52**. Typically, horizontal cracks were regularly spaced at spacings varying from 5 inches to 36 inches. Crack widths ranged from 0.01 inches or less up to 0.04 inches. There were a few instances of minor corrosion stains on the columns. No signs of efflorescence were observed.

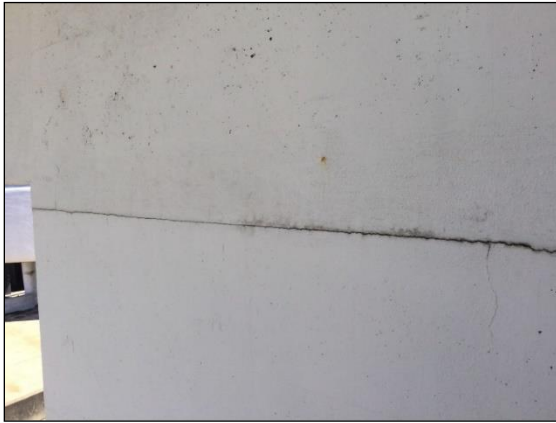
Figure 3.53

Horizontal cracks were also observed in several instances at the top of the column (**Figure 3.53**). The width of the cracks varied between 0.02 and 0.03 inches. In some instances, the crack at the top of column also had minor delamination or spalling (**Figure 3.54**).

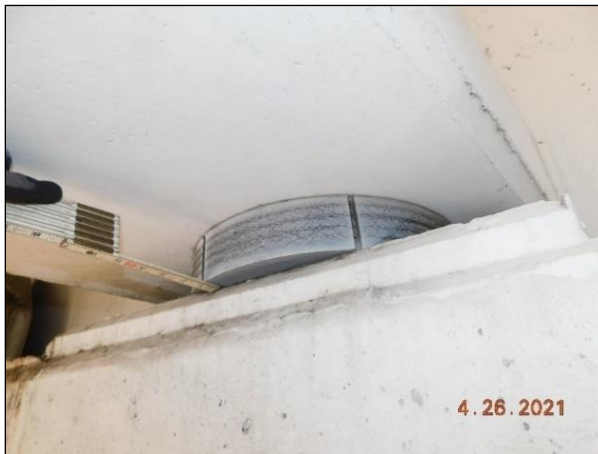
Figure 3.55

Most bearing pads were found in adequate conditions. Several pads, however, were noted to have displaced in the longitudinal and transverse direction up to about 2 inches. In some cases, the displacement is so severe that part of the pad has lost support (see **Figure 3.55** and **Figure 3.56**).

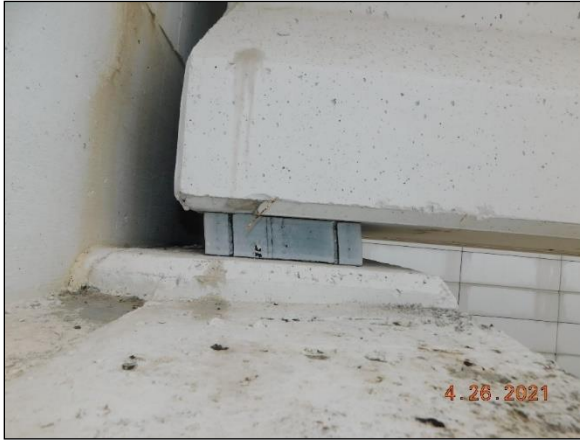
Figure 3.57

A minor issue that was observed in a few pads is permanent deformation in the longitudinal direction (see **Figure 3.57** and **Figure 3.58**). The typical deformation ranged between 0.25 and 0.50 inches.

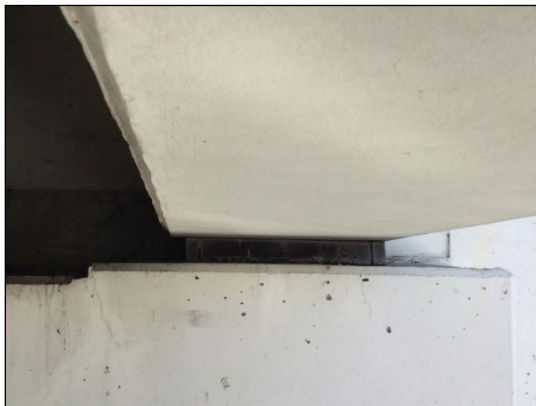
Figure 3.59

In addition, a minor issue found was that some pads were skewed about 1/4 inch, causing the bearing to not be fully in contact with the beam (see **Figure 3.59** and **Figure 3.60**). The part of the bearing pad not in contact ranged from 2 inches to 8 inches.

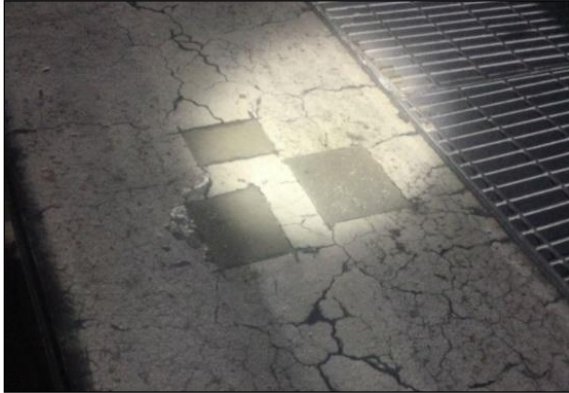
Figure 3.61

Previous repairs were observed in some running beams and columns. The running beams had both patch repairs and larger section repairs (**Figure 3.61** and **Figure 3.62**).

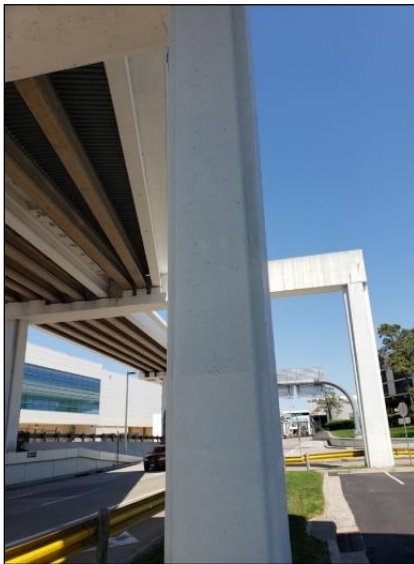
Figure 3.63

The columns also had previous small and large section repairs. **Figure 3.63** shows a column with the bottom 1/3rd repaired, and **Figure 3.64** shows a small portion of the column repaired.
