IAH APM CONDITION ASSESSMENT

**BUSH INTERCONTINENTAL AIRPORT HOUSTON (IAH)
HOUSTON, HARRIS COUNTY, TEXAS**

October 2021

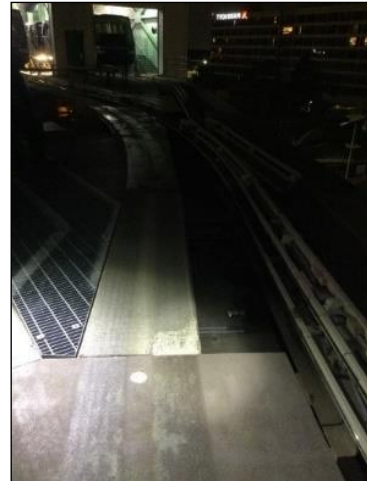
Figure 3.8

Spalling of the running beams and loose concrete were observed at switches in transitions between running beam and metal switch plate (**Figure 3.7** and **Figure 3.8**). Spalls and cracking were also very common at relief joints (**Figure 3.9**) likely from a punctured APM wheel. The depth of spalling varied between 1 and 5 inches, and in one instance the reinforcing steel was exposed. At these locations reinforcement cover is significantly reduced which is an important durability issue.

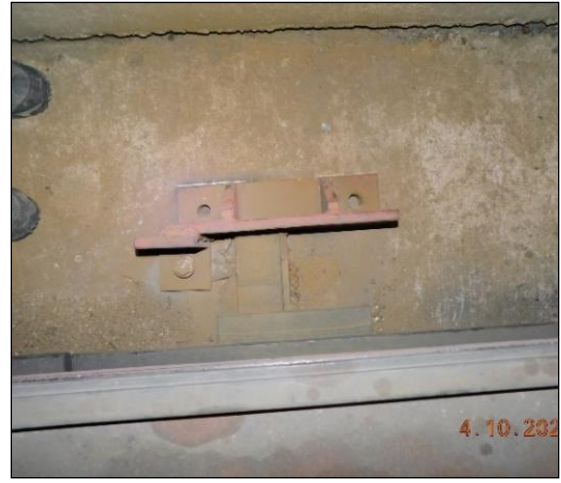
Figure 3.11

As discussed in **Section 2.1**, the steel guide beams are anchored to the deck slab using anchor rods embedded in the concrete. In most cases, grout pads were placed in the gap between the connection steel angle and the deck slab to provide a uniform bearing surface. These connections were not a focus of the inspection. However, major issues were noted including a spalled grout pad (**Figure 3.10**) and missing bolts (**Figure 3.11**). These damaged grout pads should be retrofitted to avoid further damage and eventual effects on the steel beams.

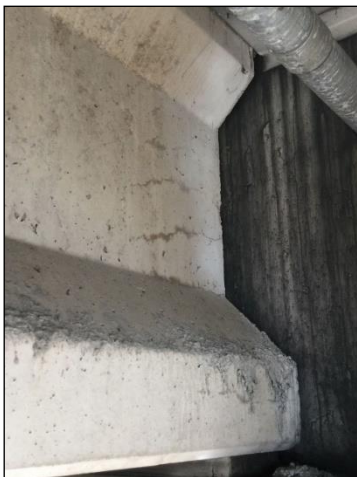
Figure 3.12

During the visual observation, the prestressed concrete beam did not display evidence of significant concrete deterioration. Honeycombing, voids during manufacturing, were observed throughout the APM beams as shown in **Figure 3.12**. A few beams showed minor cracking ranging from 0.005 inches to 0.01 inches at beam ends, also shown in **Figure 3.12**. A couple instances of spalling at the beam end was observed during inspection, as shown in **Figure 3.13**. Additionally, a single instance of a minor beam rotation was spotted, illustrated in **Figure 3.14**. This is beam 1 located on span 7 of bent 38 and has rotated in the North direction.

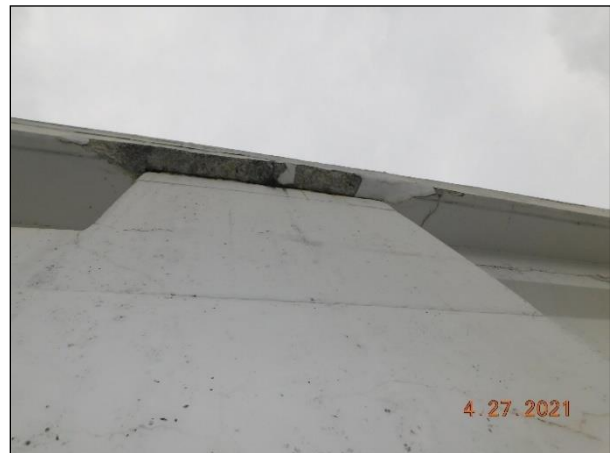
Figure 3.16

The deck curb over the bents 43, 44, and 45 is severely delaminated. As time passes the delaminated concrete may spall off completely and pose a danger to the traffic below. It is recommended that APM authorities remove the delaminated concrete in a controlled manner as soon as possible. See **Figures 3.16-3.17** for delaminated sections.

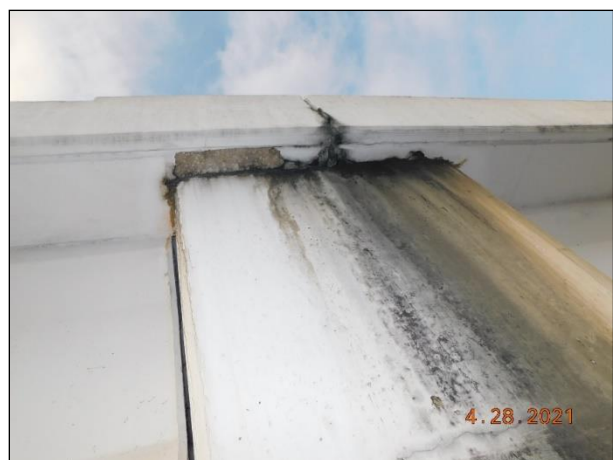
Figure 3.22

Spalls and concrete delamination were observed on deck edges all along the APM guideway. These spalls are likely due to stress concentrations and were more common at deck overhang interfaces with other bridge components such as the bent (see **Figures 3.21, 3.22, and 3.23**). Generally, the spalls do not show any evidence of active corrosion.

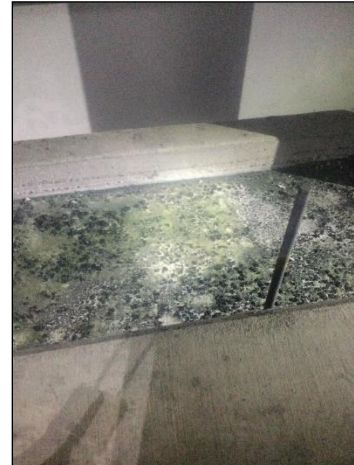
Figure 3.27

Figure 3.26 shows evidence of standing water (ponding) and **Figure 3.27** shows evidence of algae growth on the deck. It is believed that deck ponding was caused by uneven finishing of the slab top surface. While water alone would not cause damage to the slab, it may eventually lead to reinforcement corrosion.

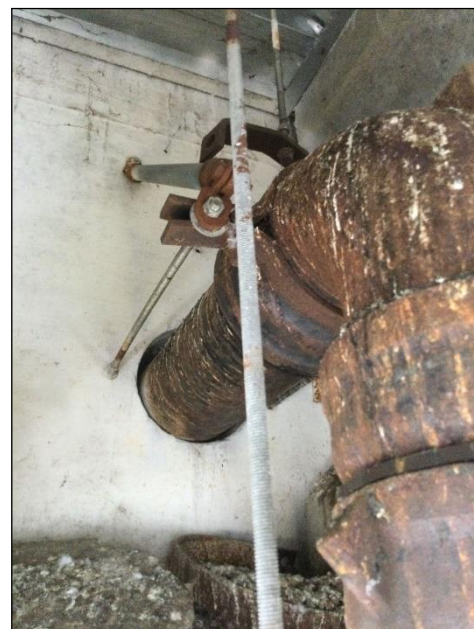
Figure 3.29

Figure 3.28 shows a loose drainage pipe support on the East face of Bent 49 between beams 1 and 2. On the west face in the same location of the same bent, **Figure 3.29** shows a deck drainage pipe. The entire deck drainage pipe saddle support is detached.

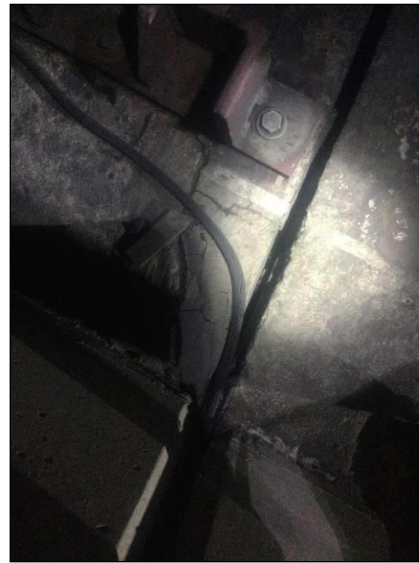
Figure 3.31

Deck expansion joints were typically observed to be in poor condition. Seals and compressible particle boards were generally loose, deteriorating or missing (see **Figure 3.30** and **Figure 3.31**). As a result, it is very common to have water leaking through the expansion joints and subsequent staining of the structure below. These stains are not only unsightly, but leakage can reduce the long term durability of the concrete elements exposed to the wetting and drying cycles. This will eventually trigger deleterious reactions in the concrete or corrosion of reinforcing steel.

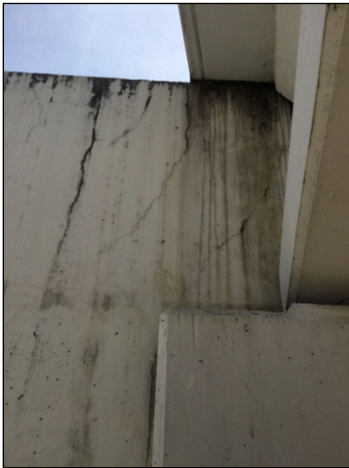
Figure 3.32

Diagonal shear cracking was observed in caps of both the hammerhead bents and the straddle bents. **Figure 3.32** shows diagonal cracking on a hammerhead bent. **Figure 3.33** shows diagonal cracking on a straddle bent. The number of cracks along the length of the bents varied from 2 to 10 cracks spaced every 2 to 5 feet. The measured lengths of the cracks varied between 2 feet and 8 feet and the measured widths varied from less than 0.01 inches to greater than 0.02 inches. Significant cracking, spalling, delamination, and evidence of active corrosion were observed in a few bent cap structures.

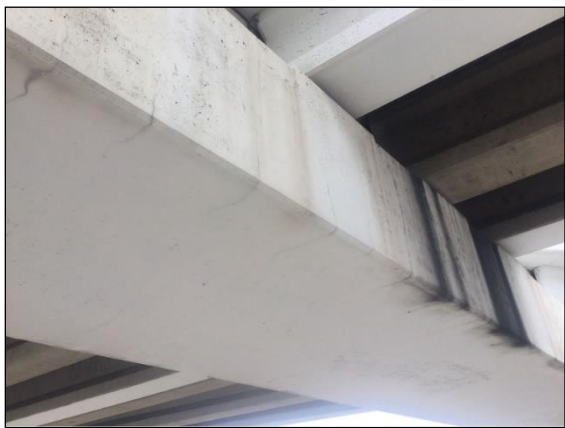
Figure 3.36 shows the typical cracking on the face of the ledge. The height of these vertical cracks varied from 1 foot to the full height of the ledge and then extended down under the cap up to 12 inches. The width of these cracks varied from 0.01 inches to 0.02 inches.

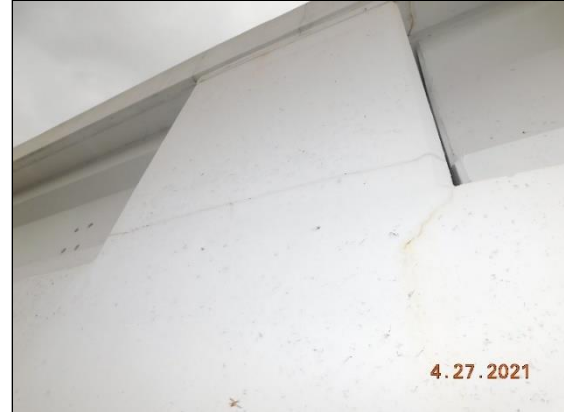
Figure 3.41

Another type of crack that was observed on the inverted-T section is shown in **Figure 3.40** and **Figure 3.41**. These large horizontal cracks were located at mid-height of the stem. The cracks extended the full width of the stem and into the length of the cap. The crack widths were measured to be between 0.01 inches and 0.03 inches.

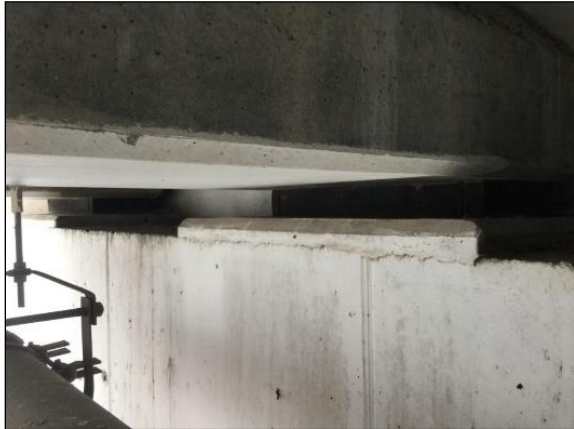
Figure 3.42

Several grout pads were moderately to severely delaminated. Grout pads were hollow the full length and from half width up to full width (see **Figure 3.42** and **Figure 3.43**).

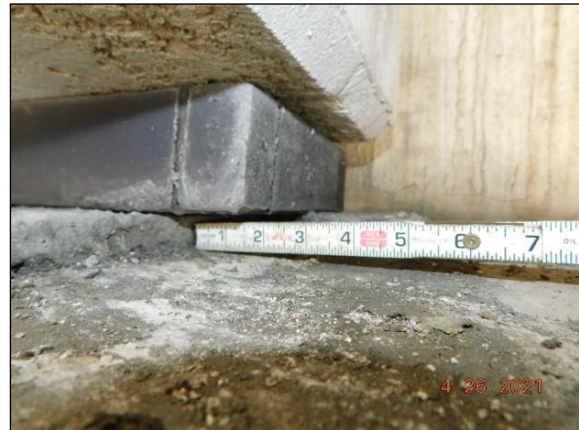
Figure 3.45

Some grout pads were spalled with loose concrete. In severe cases, the spalls would leave the bearing pad unsupported in sections (see **Figure 3.44** and **Figure 3.45**). **Figure 3.46** shows a grout pad at bent 47 that contains loose concrete and is in danger of falling.

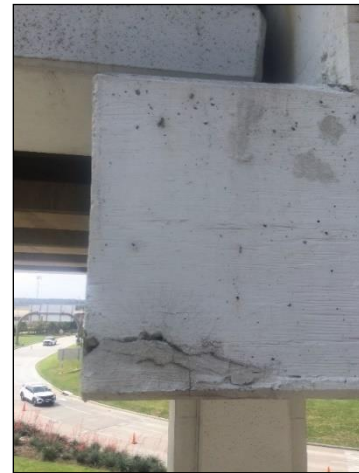
Figure 3.48

Figure 3.47 shows an instance of exposed rebar. **Figure 3.48** shows delaminated concrete that is close to spalling off. **Figure 3.49** and **Figure 3.50** show two 2.5 foot spalls at the top of the stem.

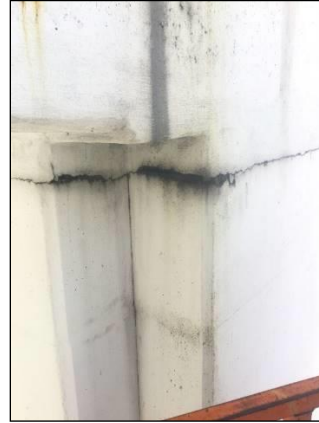
Figure 3.54

Horizontal cracks were also observed in several instances at the top of the column (**Figure 3.53**). The width of the cracks varied between 0.02 and 0.03 inches. In some instances, the crack at the top of column also had minor delamination or spalling (**Figure 3.54**).

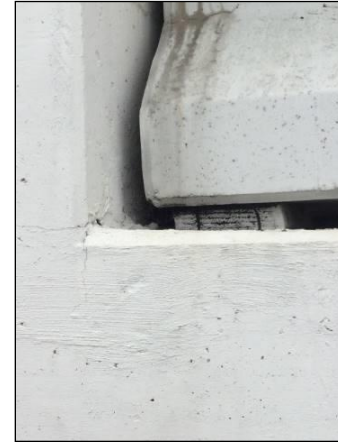
Figure 3.58

A minor issue that was observed in a few pads is permanent deformation in the longitudinal direction (see **Figure 3.57** and **Figure 3.58**). The typical deformation ranged between 0.25 and 0.50 inches.

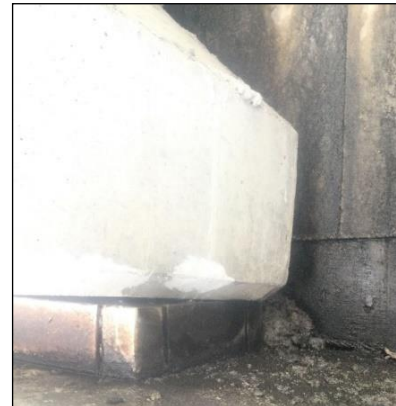
Figure 3.60

In addition, a minor issue found was that some pads were skewed about 1/4 inch, causing the bearing to not be fully in contact with the beam (see **Figure 3.59** and **Figure 3.60**). The part of the bearing pad not in contact ranged from 2 inches to 8 inches.

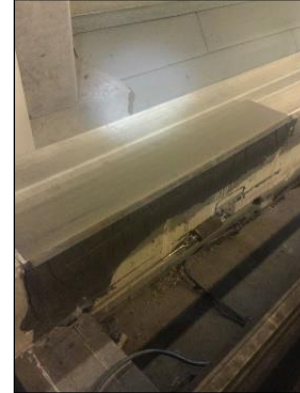
Figure 3.62

Previous repairs were observed in some running beams and columns. The running beams had both patch repairs and larger section repairs (**Figure 3.61** and **Figure 3.62**).

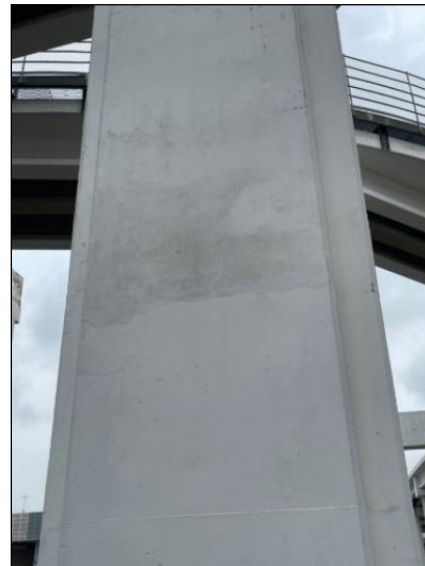
Figure 3.64

The columns also had previous small and large section repairs. **Figure 3.63** shows a column with the bottom 1/3rd repaired, and **Figure 3.64** shows a small portion of the column repaired.

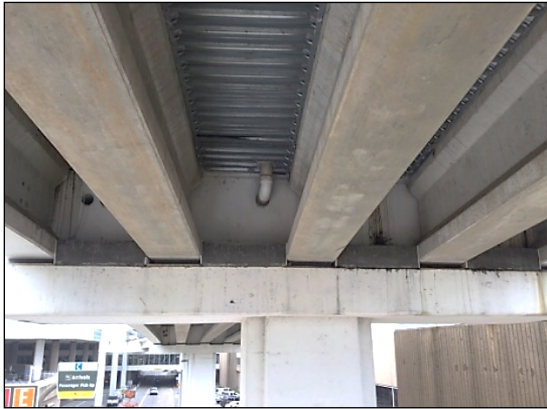
Figure 3.65

Shear keys have been installed at several bents to provide lateral transverse support to the beams (**Figure 3.65** and **Figure 3.66**).

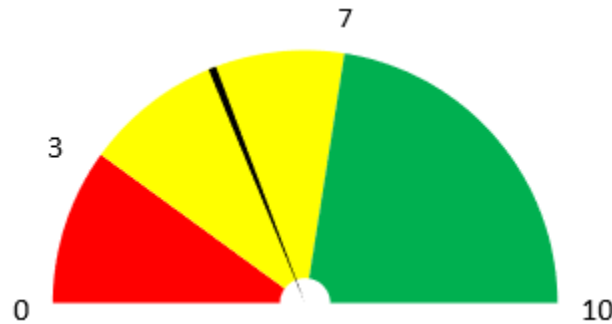
Figure 6.1: ACTUAL CONDITION INDEX (ACI)

The Actual Condition Index (ACI) is defined as the lowest rating of the deficiencies encounter during the structure visual assessment. The ACI rating for this facility has been considered to be 5.0. See **Appendix F** for individual component and subcomponent’s facility scores.

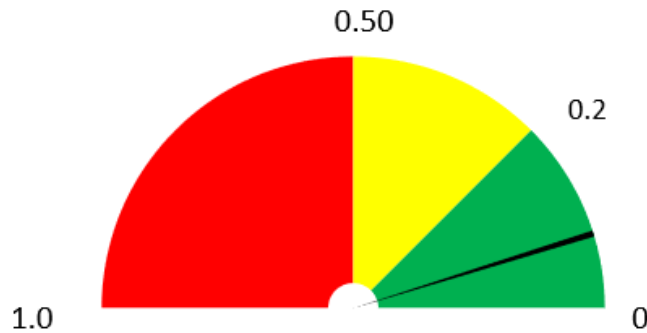
Figure 6.2: FINANCIAL CONDITION INDEX (FCI)

The Financial Condition Index (FCI) is defined as the total cost of deferred Maintenance/Current Replacement Value. The FCI value for this facility under the current condition is equal to 0.08. This value

does not account for any retrofit that the APM structure may require based on the recommended structural analysis.

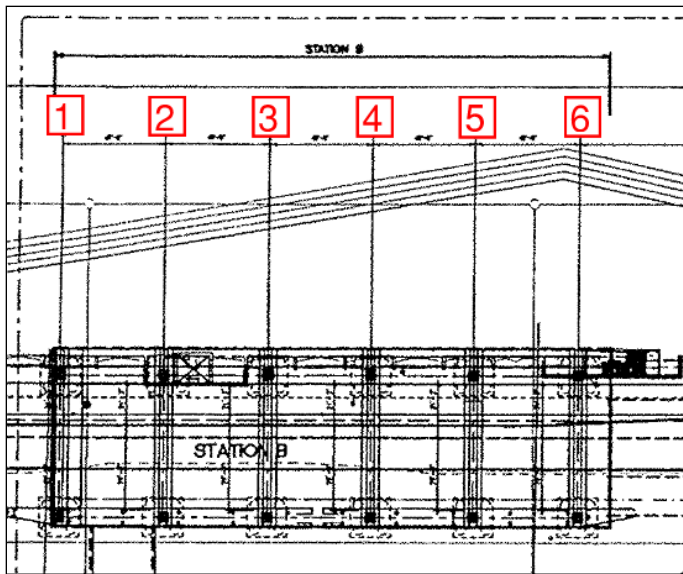
Figure 9.1

Visual inspection of the APM structures were conducted, however parts of substructure components at terminal stations were inaccessible due to clearance protocol, architectural facades, or terminal structures. Bents 1 through 5 were located inside Terminal B (**Figure 9.1**), and Bents 27 through 31 were located inside Terminal C. These bents were not accessible for inspection of the bent caps and columns.

Bent 50 was partially covered by architectural facades at Terminal D and was inaccessible for inspection of the east side of the column (see **Figure 9.2**). It is recommended that a further inspection of these bents be conducted for APM substructure components from inside the terminal buildings.
