APM CONTROLS ASSESSMENT & CONTROL ROOM RELOCATION

Project Number: 83498

June 2015

BURNS & MCDONNELL

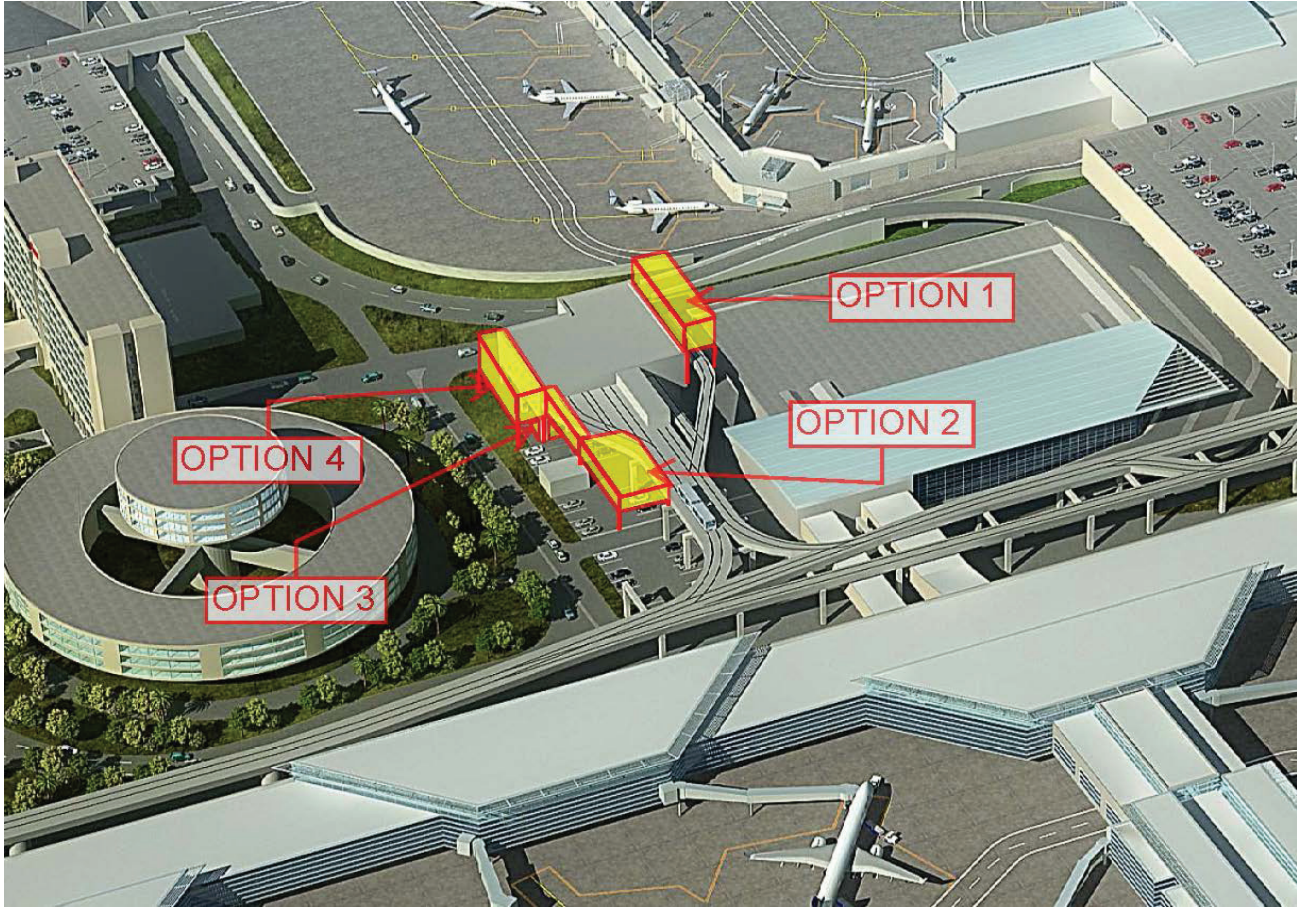
LARGE SCALE VIEW OF CONTROL ROOM OPTIONS

Overview of Control Center Location Options

- Option 1 - Elevated Space over APM Storage Track
- Option 2 - Extend Mezzanine Level Space
- Option 3 - Parking Lot Space Under the Maintenance Facility
- Option 4 - Elevated on East Side of Maintenance Facility
- Option 5 - Remodeling of Existing Control Room

For preliminary planning purposes a one story space of 40' x 60' (2,600 sf, basic needs plus an allowance for circulation) was used to determine suitable locations. Four primary options have been reviewed for a new Control Center. An assessment was also done of the potential for remodeling the existing Control Room and associated facilities. The comparison review is included as **Option 5**.

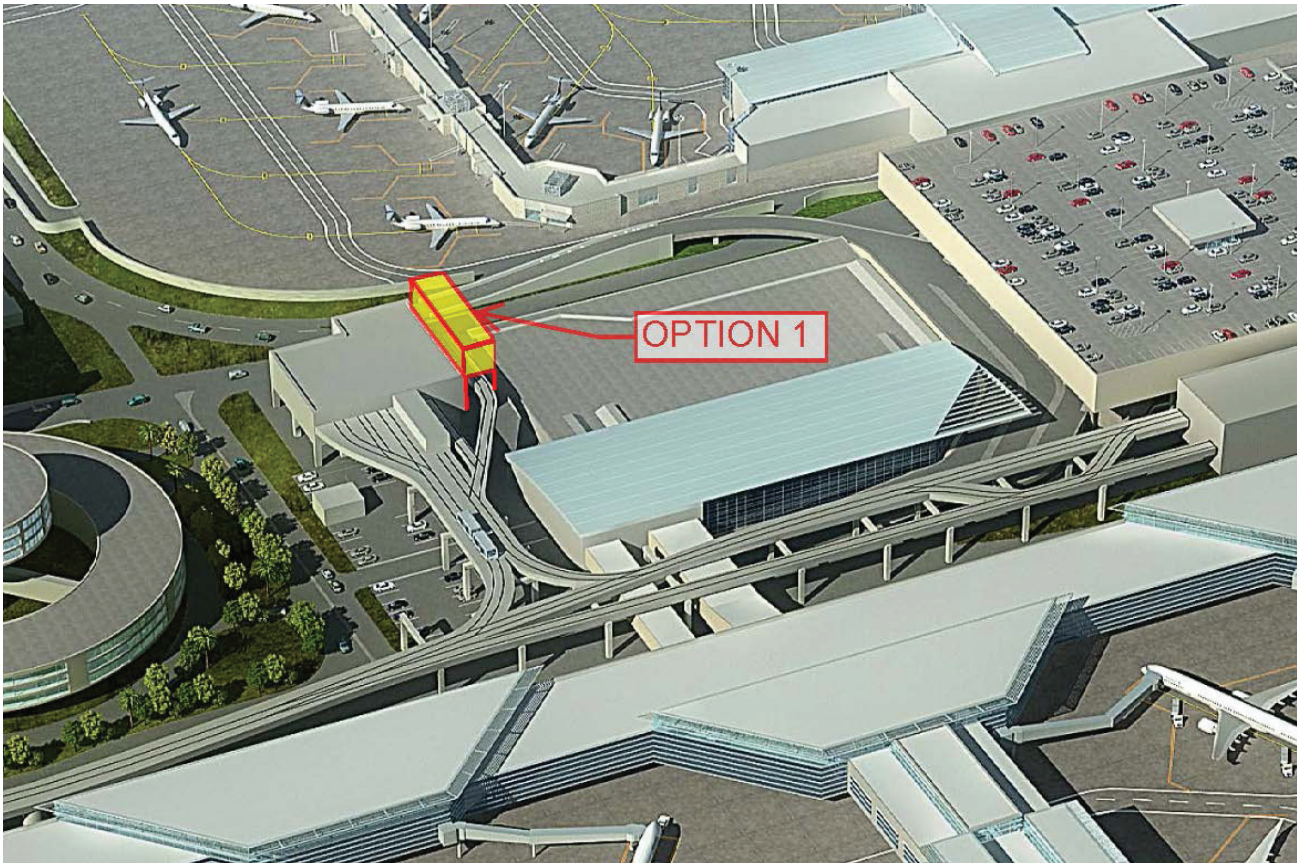
OPTION 1 - ELEVATED SPACE OVER APM STORAGE TRACK

- Pros**
- Near to Offices and Maintenance Operations
 - Consolidates APM functions
 - Isolates Control Center from Terminal functions
 - Little Impact to Adjacent Spaces

- Cons**
- Elevated Construction Cost is higher
 - Pedestrian Traffic is complicated due to offset levels
 - Vertical Circulation is complicated because of tracks below
 - Access to the Maintenance Facility is complicated

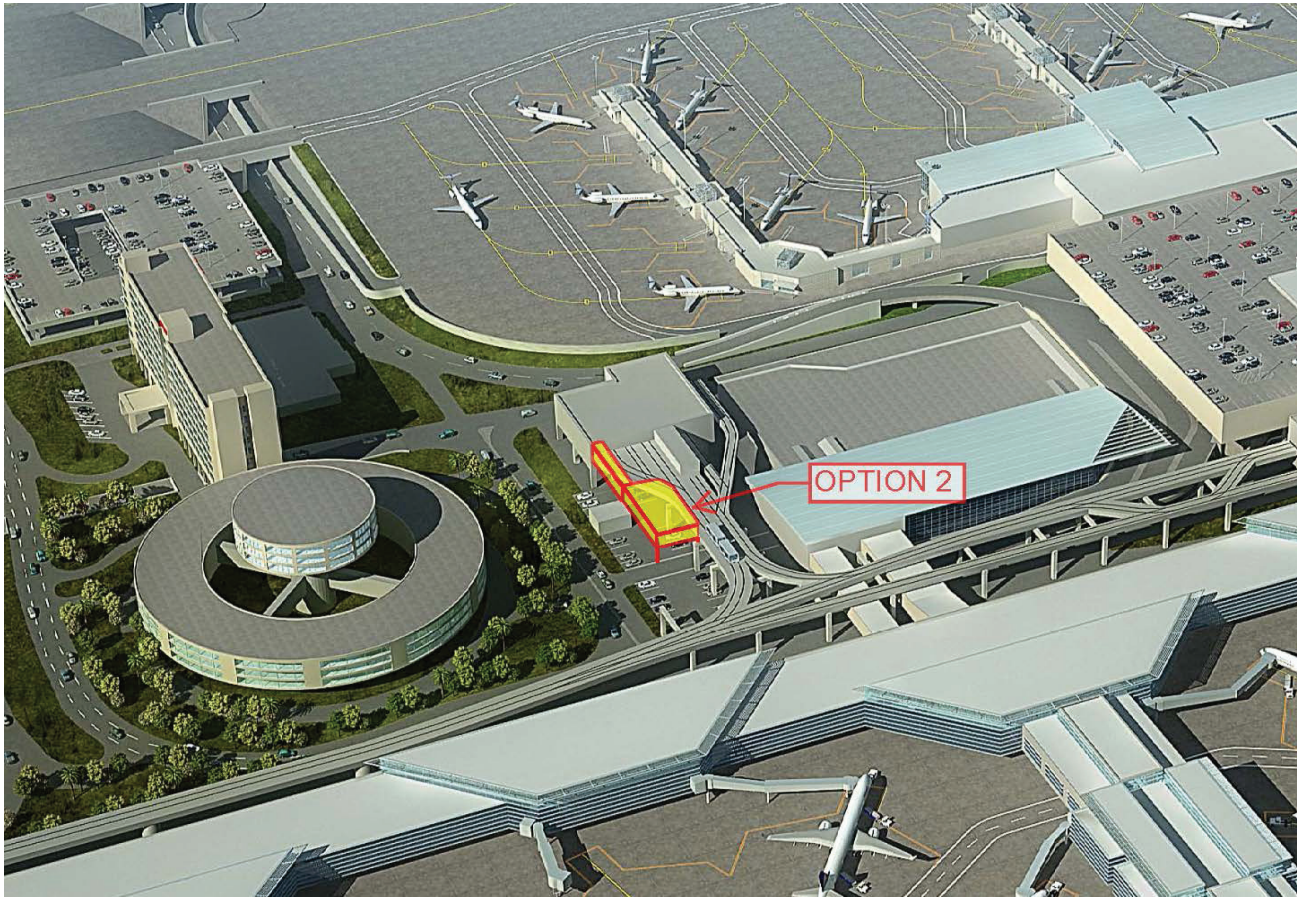
OPTION 2 - EXTEND MEZZANINE LEVEL SPACE

- Elevated Construction Cost is higher
- Vertical Circulation is complicated because of tracks below
- Access to the Maintenance Facility is complicated
- Pedestrian circulation to Offices is inconvenient
- Construction conflicts with service tracks
- Significant disruption to Offices and Operations during construction

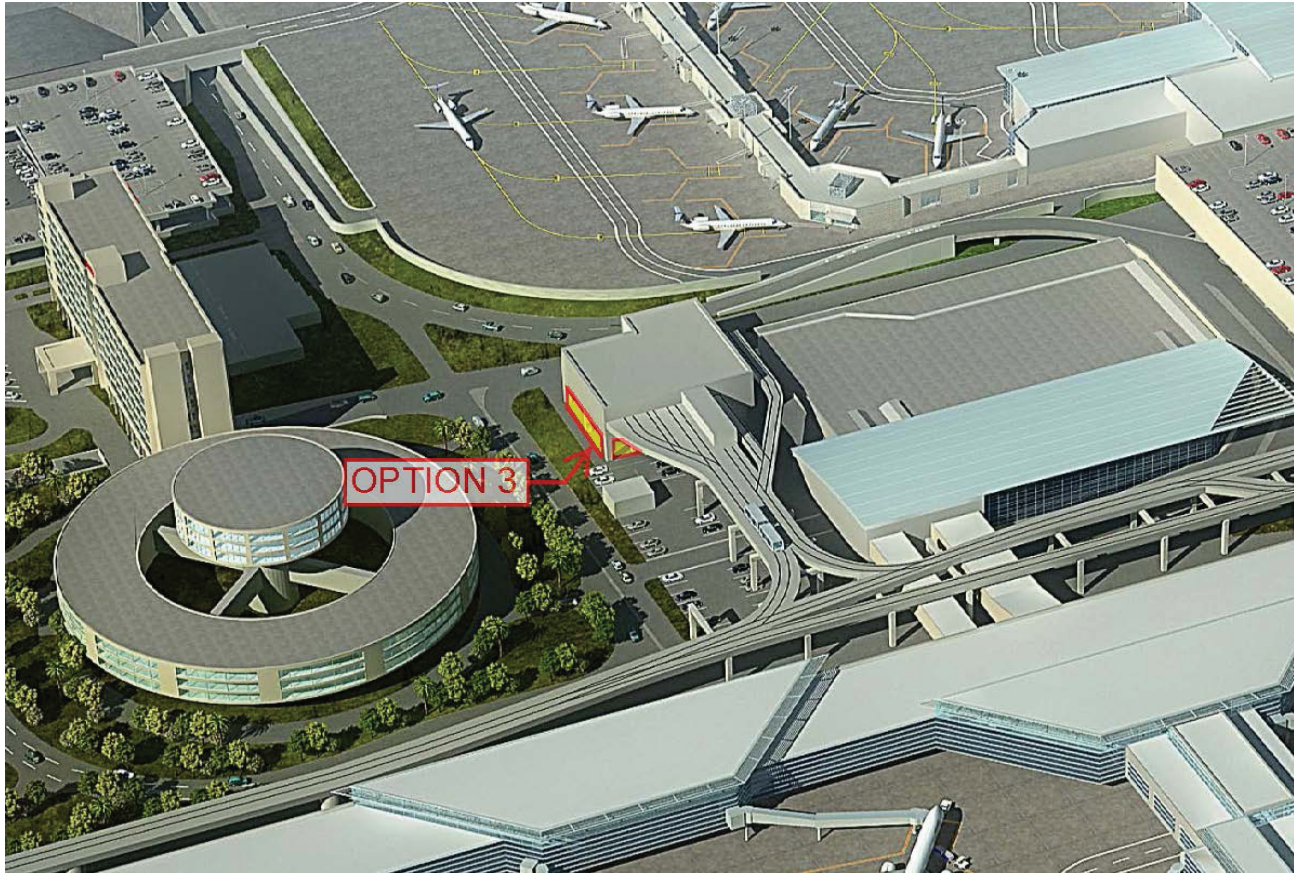
OPTION 3 - PARKING LOT SPACE UNDER THE MAINTENANCE FACILITY

- Pros**
- Located at Ground Level
 - Vertical circulation needed to access Maintenance Offices
 - Minimal disruption to Offices and Operations during construction
 - Minimal cost of remodeling existing Facility
 - Consolidates APM Control Center operations to one story
 - Isolates Control Center from Maintenance operations and Terminals

- Cons**
- Eliminates some parking
 - Requires Men’s and Women’s toilet rooms
 - Access to the Maintenance Facility is complicated
 - Pedestrian circulation to Offices is inconvenient

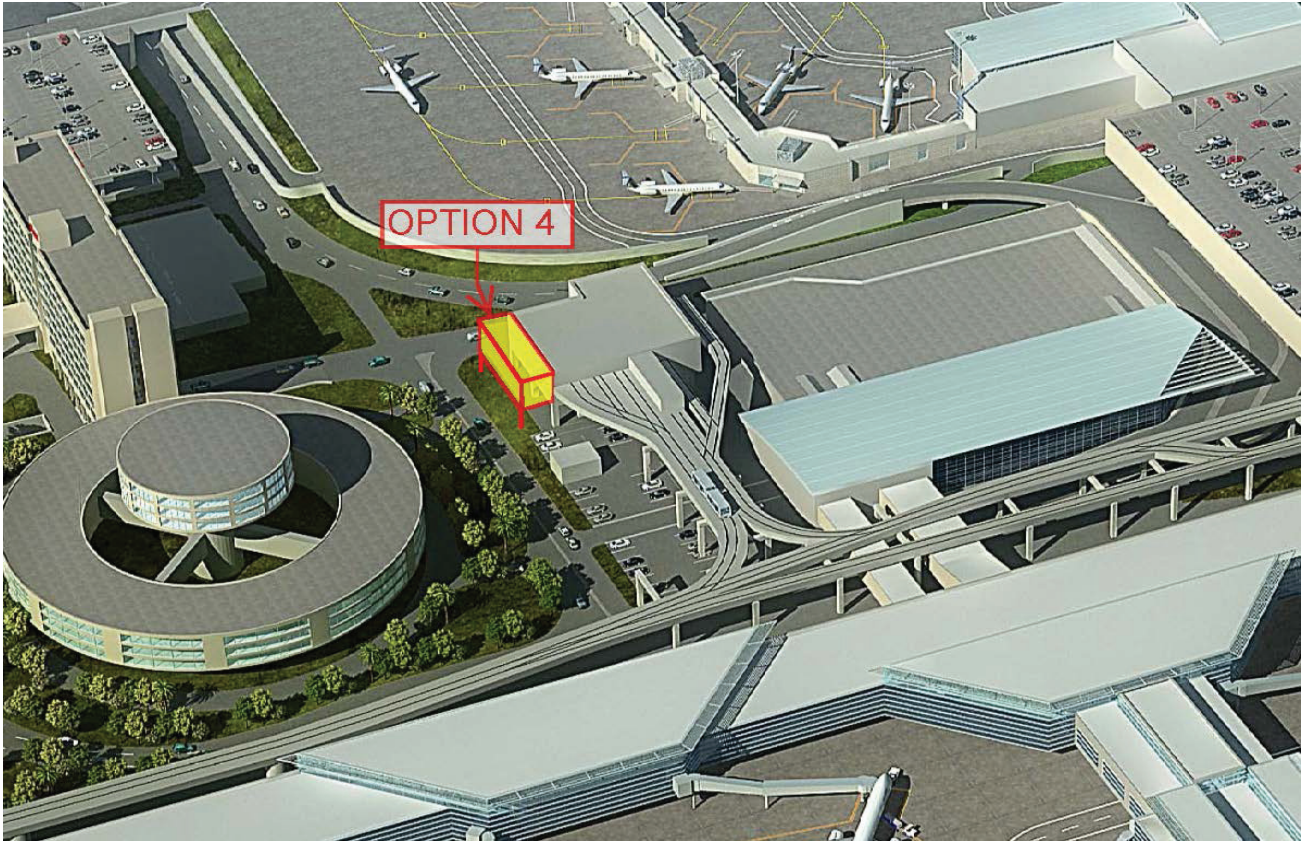
OPTION 4 - ELEVATED ON EAST SIDE OF MAINTENANCE FACILITY

- Elevated Construction Cost is higher
- Vertical Circulation necessary
- Access to the Maintenance Facility is complicated
- Pedestrian circulation to Offices is inconvenient
- Disruption to Offices and Operations during construction

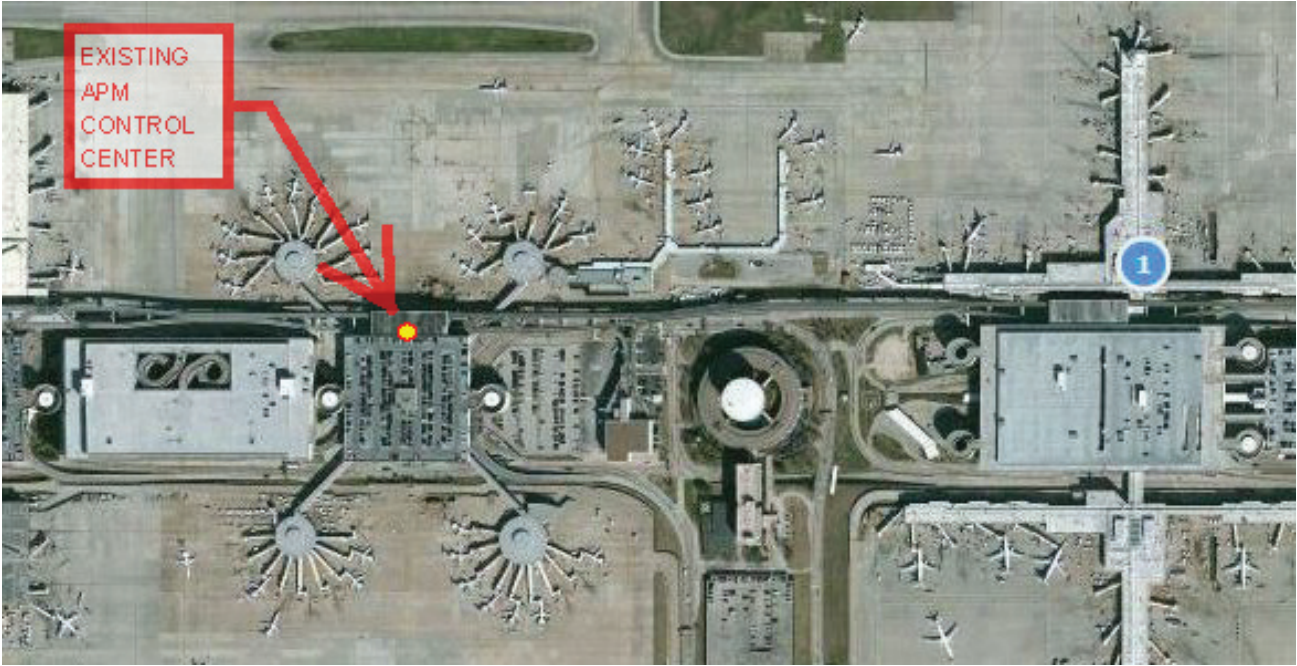
OPTION 5 - REMODELING OF EXISTING CONTROL ROOM

Pros Less Construction Cost to Remodel Existing than Construct New
No Interference with Tracks or Trams during Construction

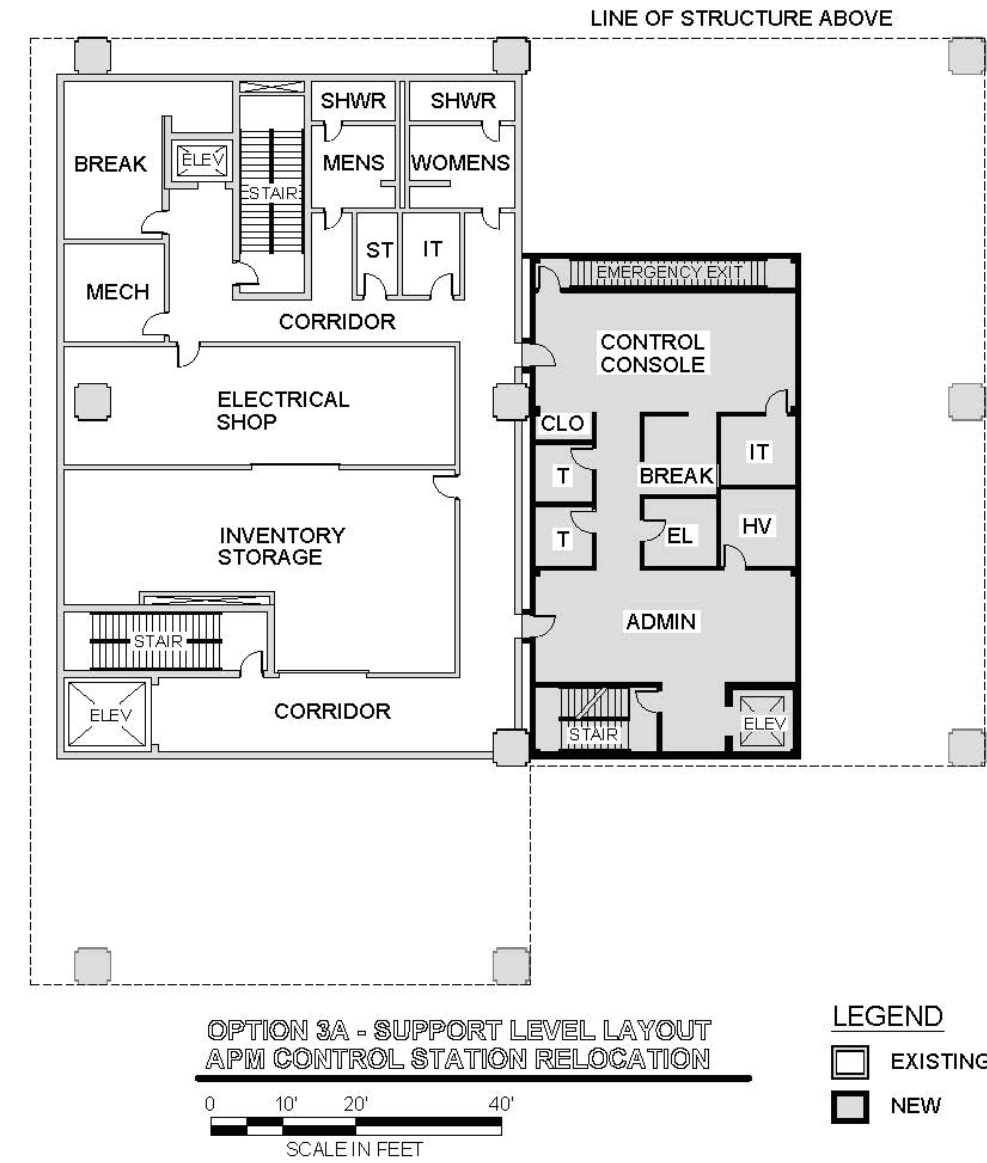
OPTION 3A - PARKING LOT SPACE UNDER THE MAINTENANCE FACILITY

Advantages to Option 3A include consolidation of all new operations on one level, connection to the existing Maintenance Facility operations, minimal interference with the existing Maintenance Facility, and minimal interference with APM track and car operations. Stairs have been included to serve the Control Center separate from the Maintenance Facility to allow the Center to function completely independently of the Maintenance facility. It may be possible to eliminate one of the stairs depending on the access and security arrangements between the two facilities.

The following diagrammatic floor plans were developed to aid in the review of viable options. These include floor plans of Option 3 and Option 4. Additionally in the development of Option 3, a variation of Option 3, Option 3A, was developed and added as an additional potential solution. Option 3A provides some significant advantages to incorporating the Control Center into the Maintenance Facility. The advantages are listed below the floor plans for Option 3A.

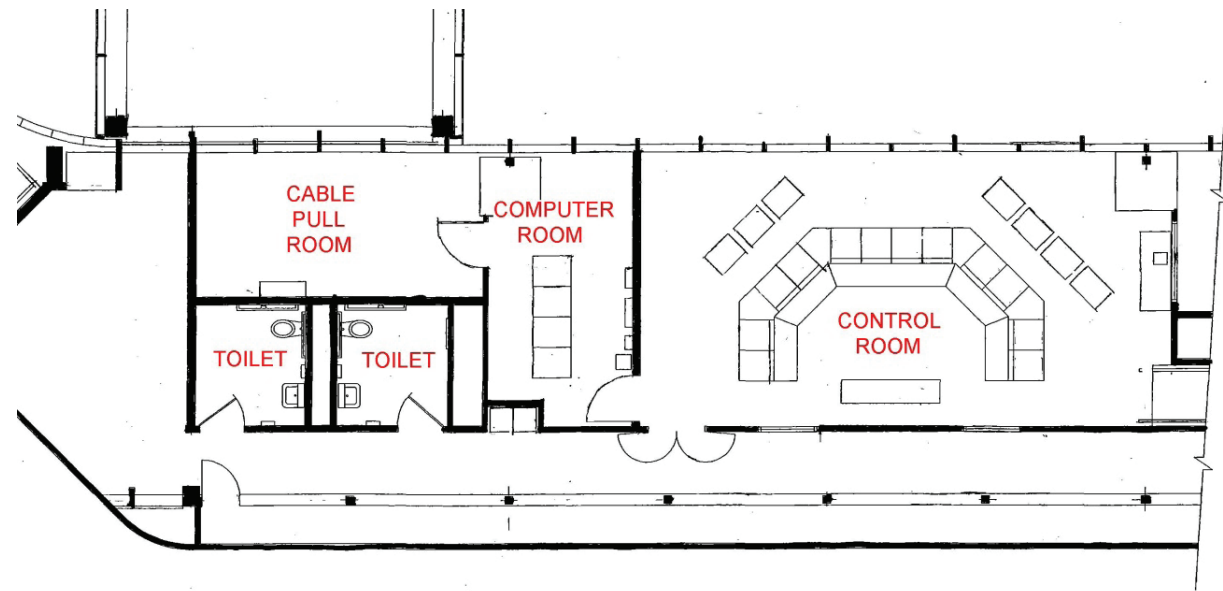
LAYOUT OF EXISTING CONTROL CENTER

- c) Install new static resistant flooring
 - d) Remodel the existing HVAC ductwork to accommodate the new ceiling and clean portions of ductwork to remain
- 3) Cable Pull Room
 - a) Install new acoustic tile ceilings
 - b) Install new recessed lighting
 - c) Install new static resistant flooring
 - d) Remodel the existing HVAC ductwork to accommodate the new ceiling and clean portions of ductwork to remain
- 4) Two Toilet Rooms
 - a) Install new acoustic tile ceilings
 - b) Install new recessed lighting
 - c) Install new static resistant flooring
 - d) Remodel the existing HVAC ductwork to accommodate the new ceiling and clean portions of ductwork to remain
- 5) Circulation
 - a) Install new acoustic tile ceilings
 - b) Install new recessed lighting
 - c) Remodel the existing HVAC ductwork to accommodate the new ceiling and clean portions of ductwork to remain
